Pentagon & Boeing 757 Engine Investigation

I've seen pictures of engine wreckage at the Pentagon after 9/11. Your site says the engine of a 757 is over 6 feet across but this piece is way smaller than that. Does it prove that whatever hit the Pentagon was not a 757 and the government is lying about it?

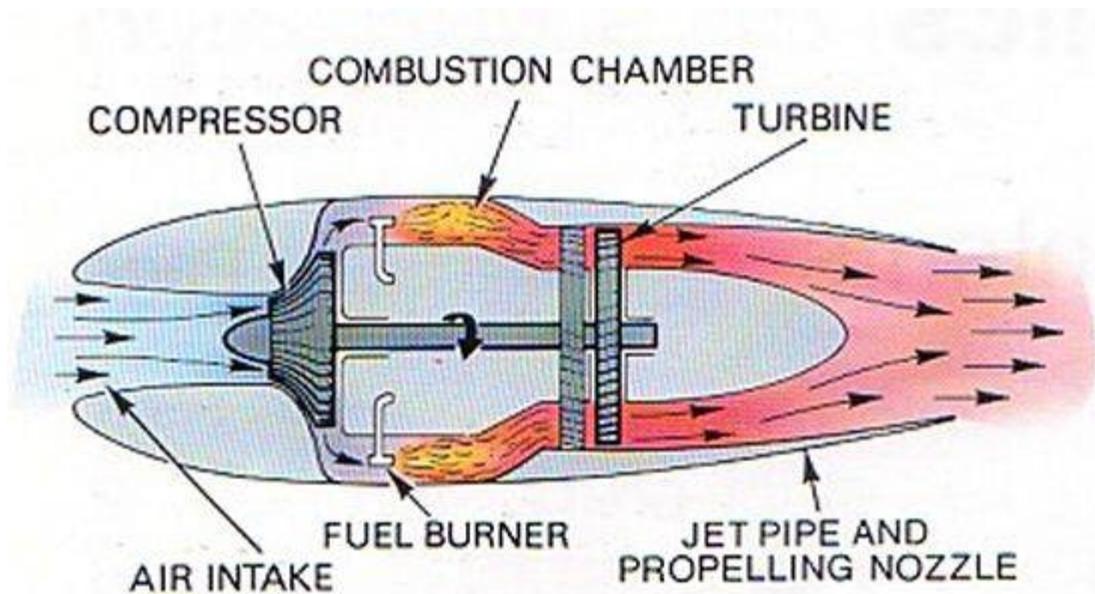
Schematic of a simple jet engine

In order to better understand the parts of a jet engine and how this form of propulsion works, let us briefly revisit the different [types of jet engines](#). The earliest form of jet propulsion was the [turbojet](#). This type of powerplant employs a series of compressor blades mounted on rotating disks that squeeze incoming air to a higher pressure and temperature. The compressed air is then mixed with fuel and ignited. The high temperature air passes through another series of rotating blades called a turbine, which causes this turbine to spin. The turbine rotors are attached to a central shaft running the length of the engine, so the turbine's spinning motion causes this shaft to rotate as well. Also attached to the same central shaft is the compressor section at the front of the engine. This connection between the turbine and compressor sections causes the compressor stages to continue spinning, bringing in additional air to keep the engine functioning in a repeating cycle. Once the airflow moves past the turbines, it is exhausted through a nozzle. The expansion of the high pressure gases against the nozzle walls creates thrust that pushes the engine forward, as well as the vehicle it is attached to.

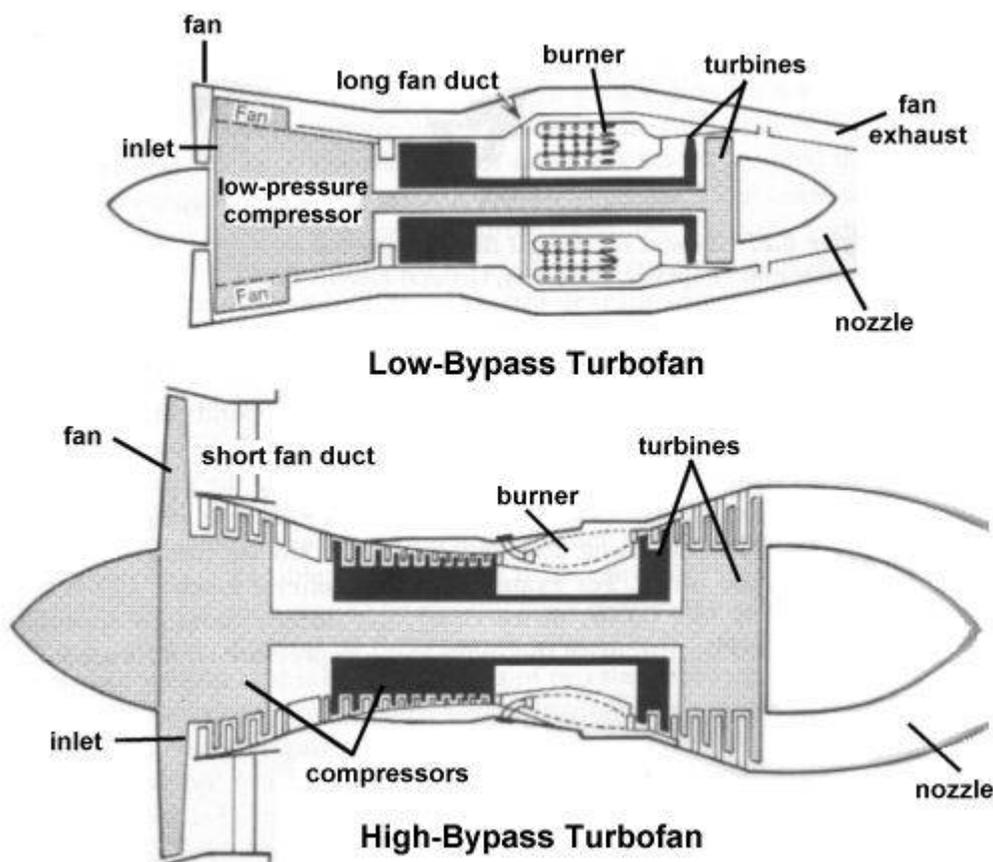
Comparison of a low-bypass turbofan with long ducts and a high-bypass turbofan with short ducts

As shown in the above diagram, a turbofan contains many rotating compressor and turbine disks, all of which are smaller than the fan at the front of the engine. The rotary components within a high-bypass turbofan, in particular, are often only a small fraction of the fan diameter. Most specifications describing the overall size of an engine will list the fan diameter since this measurement defines the engine's maximum width. Our earlier article about the 757 uses this dimension to compare the diameter of the engine nacelle to that of the fuselage.

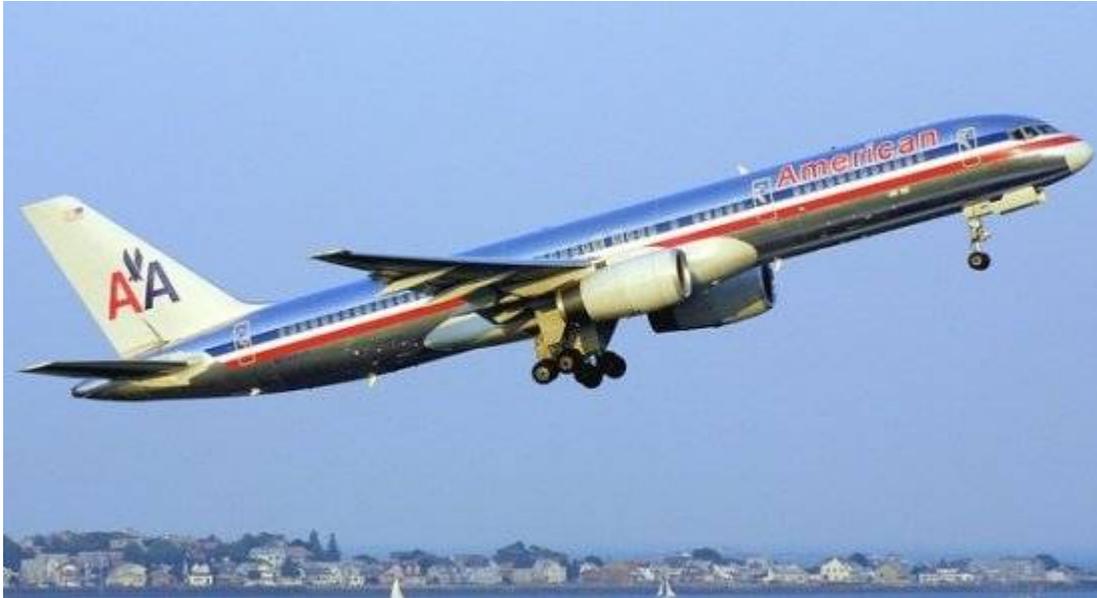
American Airlines Boeing 757-200 with tail number N644AA

According to the accepted story, American Airlines Flight 77 was hijacked by five al Qaeda terrorists as it was traveling from Washington DC to Los Angeles. The aircraft involved in this hijacking was a Boeing Model 757-200 with the [Boeing customer code](#) 757-223 and the [registration number](#) N644AA. This same aircraft is pictured above in a photo taken at Logan International Airport in Boston on 7 August 2001. The terrorists steered the plane into the west side of the Pentagon killing 59 passengers and crew as well as 125 victims on the ground.

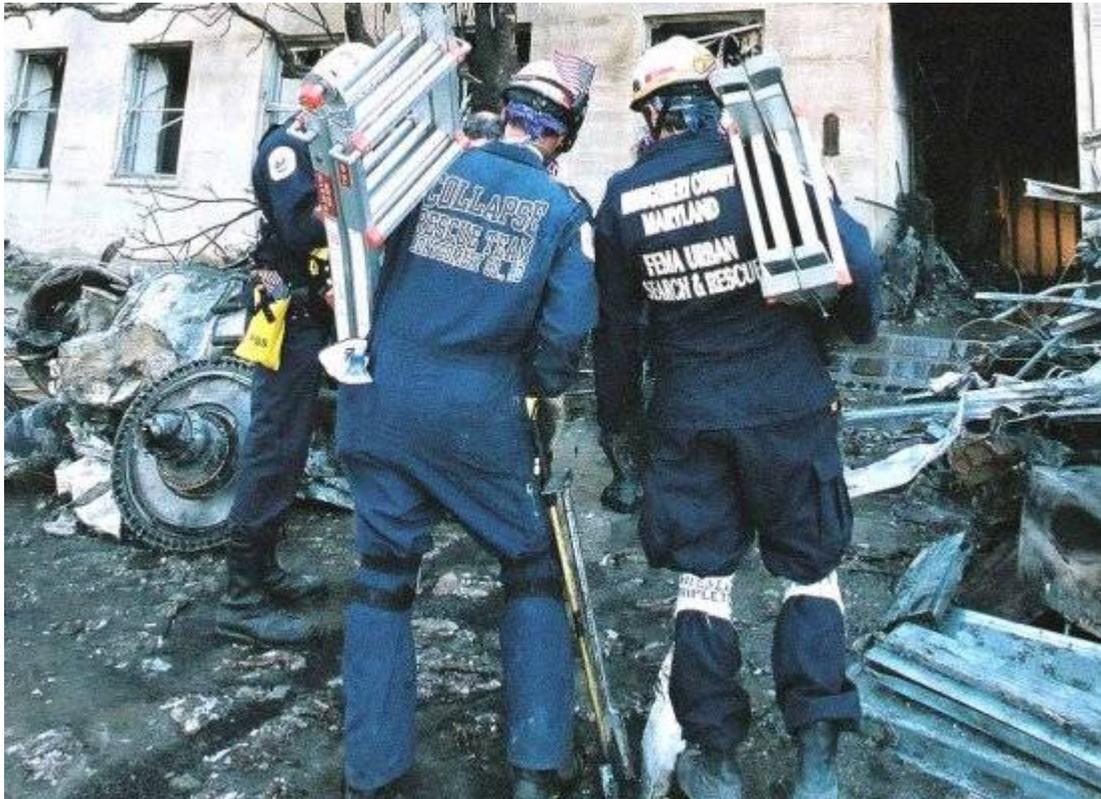
Those who doubt this version of events point to wreckage at the Pentagon as proof that some other kind of aircraft or missile was actually responsible for the attack. Probably the one piece of debris that has prompted the most debate is the following photo of what looks like a rotary disk from the interior of the plane's engine. This disk could be part of a fan, a compressor, or a turbine rotor from inside the engine, but the blades are not present and were presumably knocked off in the impact.

Rotating engine disk visible at the Pentagon

Based on the sizes of the person standing next to the debris and other objects in the photographs that we can use for comparison, it has been estimated that the disk is approximately 25 to 30 inches (63.5 to 76.2 cm) across. Obviously, this piece is far smaller than the maximum engine diameter of 6 feet (1.8 m) or more leading many to draw the conclusion that the item is not from a 757 engine. That conjecture causes conspiracy theorists to believe that a much smaller vehicle must have struck the Pentagon instead.

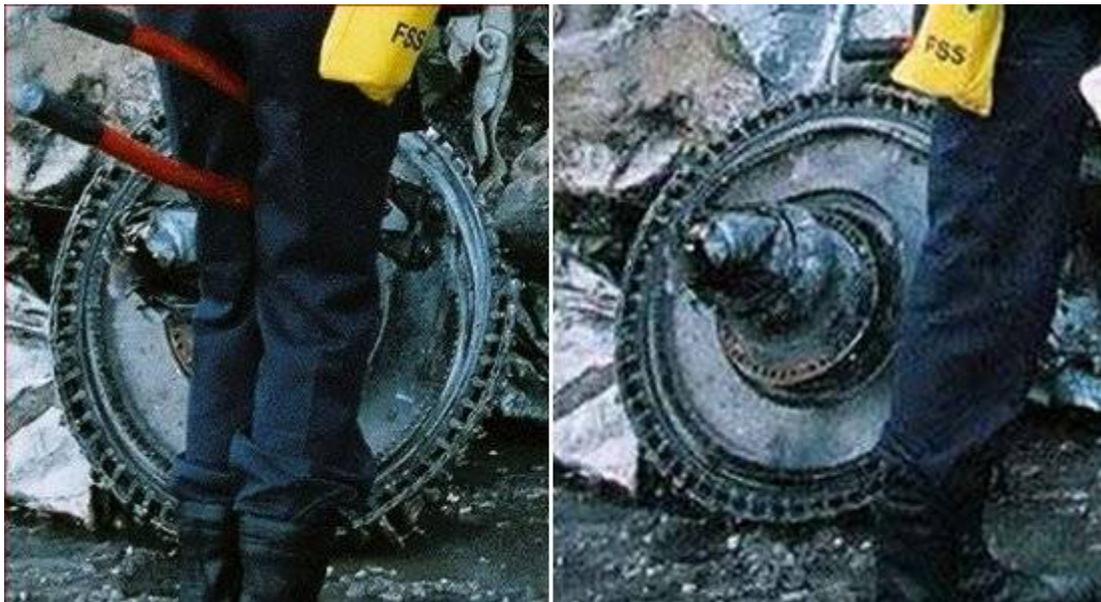
Close-up views of the Pentagon engine component

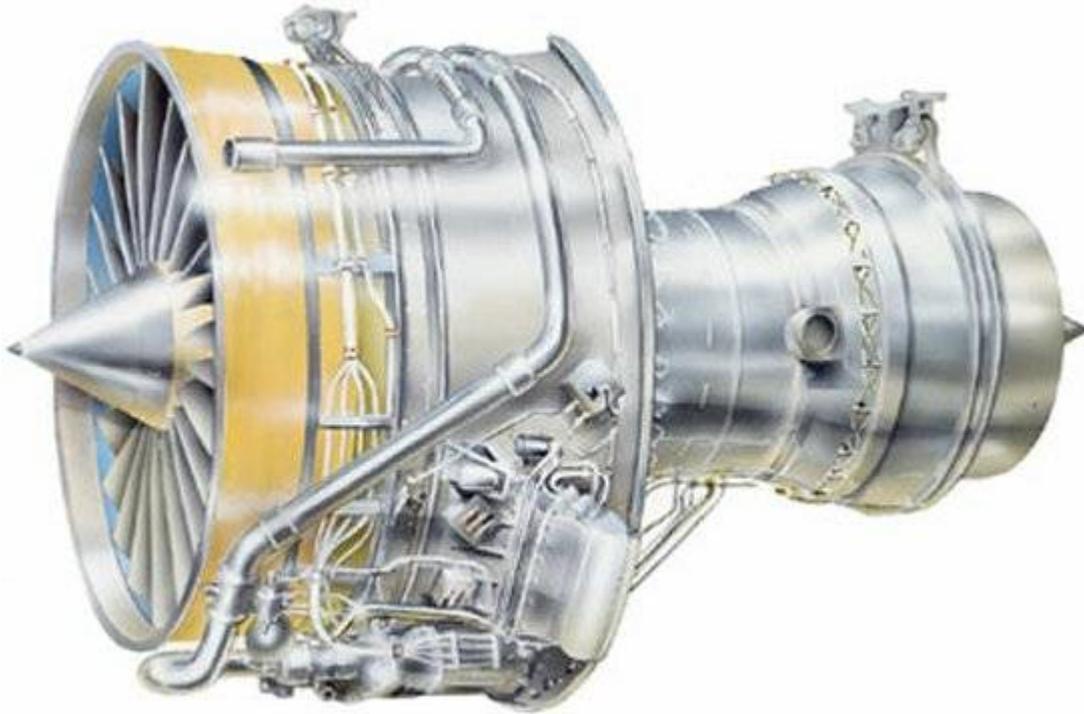
Diagram of the Rolls-Royce RB211-535 turbofan

Note the relative sizes of the forward portion of this engine compared to the central core. Clearly, the section housing the fan is much wider than the turbojet core that contains the compressor and turbine components. We can get a clearer view of the relative sizes of components within this engine in the following cut-away drawing of the RB211-535.

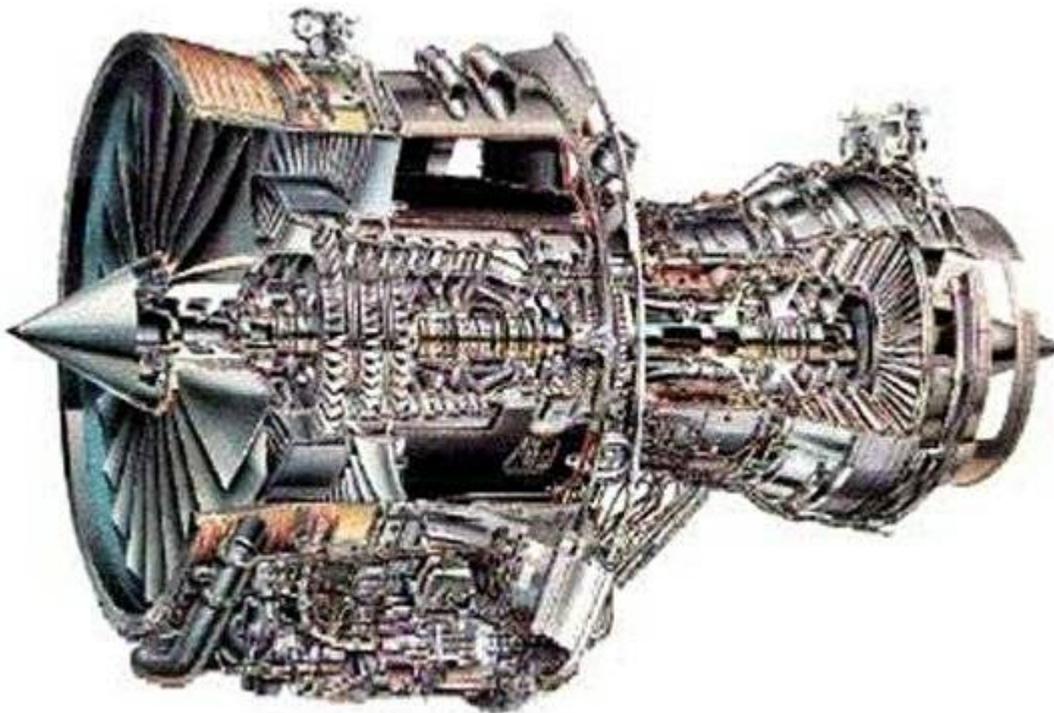
Cut-away of the Rolls-Royce RB211-535 turbofan

Using these images and other diagrams of the RB211-535 engine, we can obtain approximate dimensions of the engine's rotary disks for comparison to the item found in the Pentagon rubble. Our best estimate is that the engine's twelve compressor disk hubs (without blades attached) are about 36% the width of the fan. The five turbine disk hubs appear to be slightly smaller at approximately 34% the fan diameter. According to [Brassey's World Aircraft & Systems Directory](#) and [Jane's](#), the fan diameter of the RB211-535E4B engine is 74.5 inches (189.2 cm). It then follows that the compressor disk hubs are approximately 27 inches (69 cm) across while the turbine disk hubs are about 25 inches (63.5 cm) in diameter. Both of these dimensions fit within the range of values estimated for the engine component pictured in the wreckage at the Pentagon.

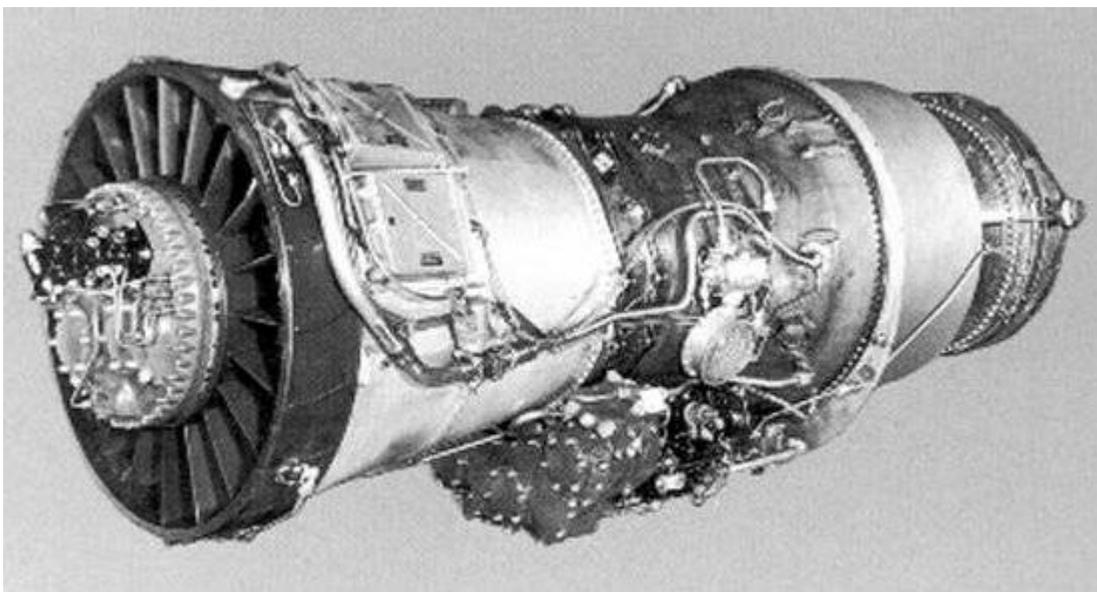
For the sake of this investigation, the only issue we shall consider is the engines that power both planes. The A-3 was equipped with two [Pratt & Whitney J57](#) turbojets like that pictured below. The J57 dates to the early 1950s and is rather antiquated by today's standards.

Pratt & Whitney J57 turbojet

PW J57	40.5 in (102.9 cm)	16 in (40.6 cm)	18 in (45.7 cm)
PW JT8D	49.2 in (125 cm)	21.5 in (54.6 cm)	22.5 in (57.1 cm)
RR AE3007H	43.5 in (110.5 cm)	14 in (35.6 cm)	15 in (38.1 cm)

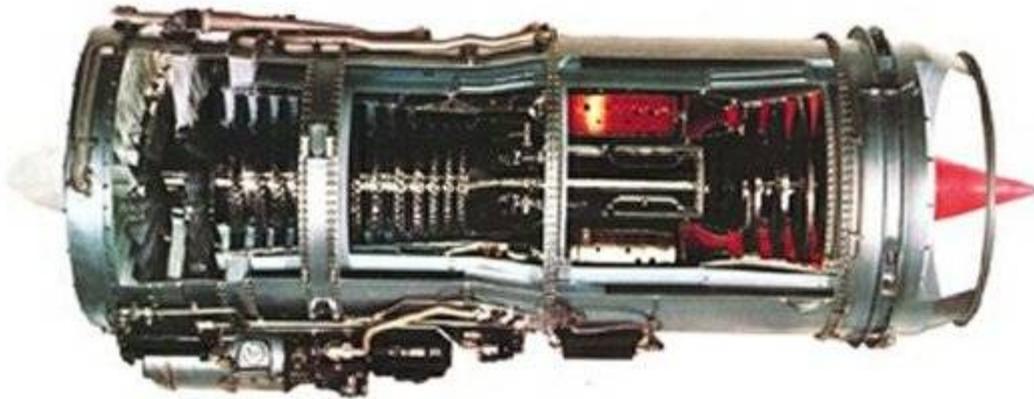
For some reason, most of the conspiratorial sites instead make extensive reference to the A-3 being powered by a [Pratt & Whitney JT8D](#) engine. Moreover, these sites claim that the JT8D is a turbojet. The JT8D is actually a low-bypass turbofan that was developed for use aboard commercial aircraft like the [727](#) and [737](#). We have not found any source that indicates the JT8D was ever used on the A-3 Skywarrior, so it is unclear why the originators of the A-3 theory are so infatuated with this particular powerplant. Nevertheless, we will include it in our investigation for completeness.

Pratt & Whitney JT8D turbofan

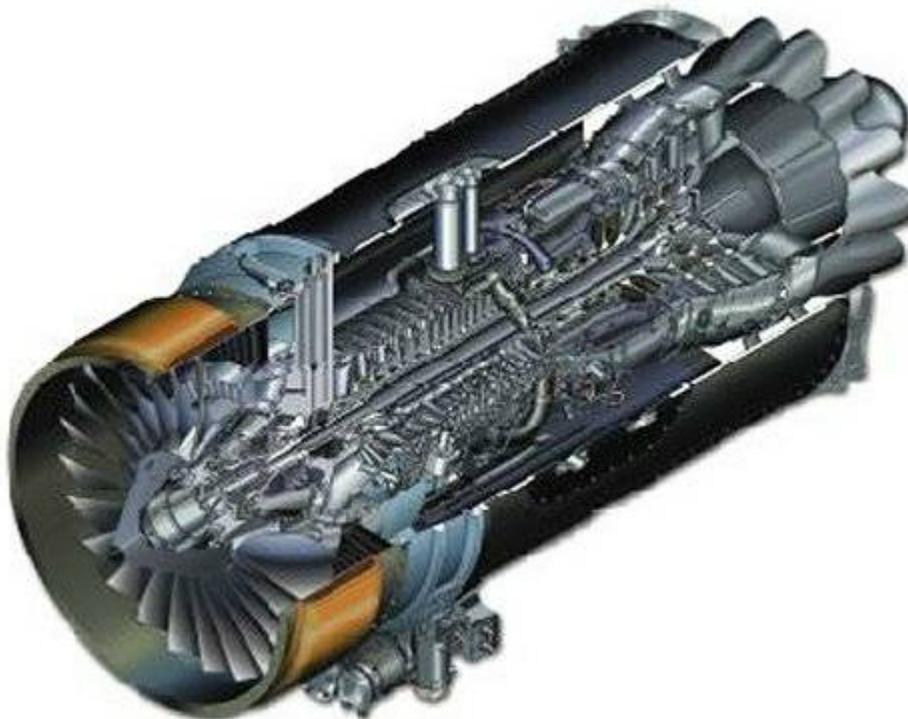
The Global Hawk, meanwhile, is powered by a single [Rolls-Royce AE3007H](#) turbofan. The AE3007 is built by the Allison Engine division of Rolls-Royce located in Indianapolis, Indiana.

Rolls-Royce AE3007 turbofan

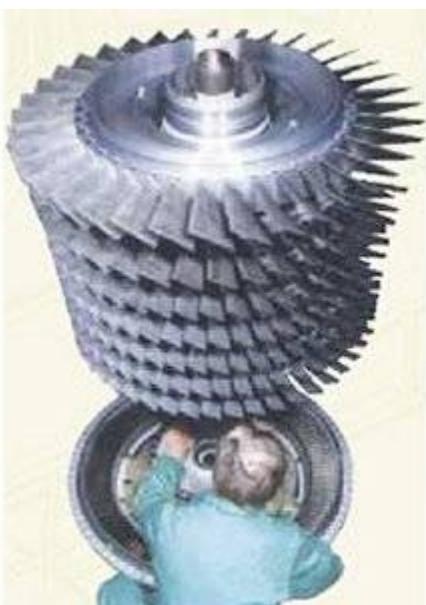
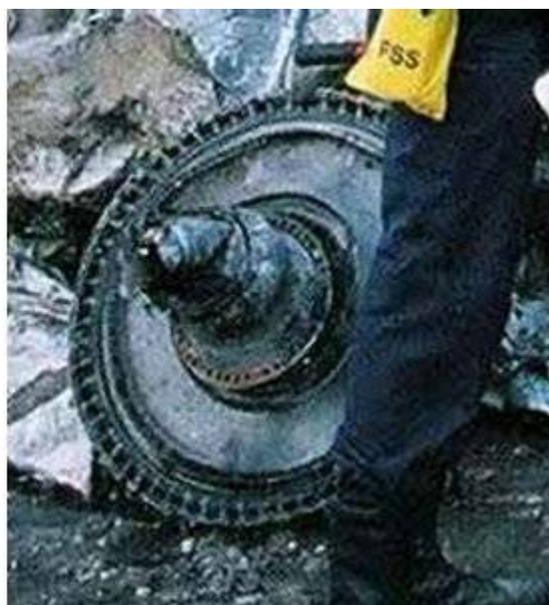
Comparison of intermediate pressure compressor stages on the RB211 to the wreckage

One similarity between the two photos can be seen in the cleats along the edge of the Pentagon object. These devices are called dovetail slots and provide attachment points for the compressor blades. The shapes of these slots on the Pentagon wreckage appear to match those on the RB211 assembly shown on the left. Furthermore, the "nosepiece" jutting out from the center of the disk in the Pentagon photo shares commonalities with the central shaft visible in the RB211 photo.

The above analysis indicates that the Pentagon debris does in fact match the characteristics of a rotor disk from the Rolls-Royce RB211-535. The wreckage is most likely a compressor stage given the shape of the dovetail slots. It is difficult to be certain exactly which compressor disk it is since the six rotors of the intermediate pressure section and six high pressure compressor disks are of similar size. The primary difference from one compressor to the next is the smaller span of the compressor blades as the air flows further into the engine, but these blades are no longer attached to the wreckage. However, additional clues in the photo suggest the rotor disk is probably from the high pressure section or perhaps the very last disk of the intermediate pressure compressors.

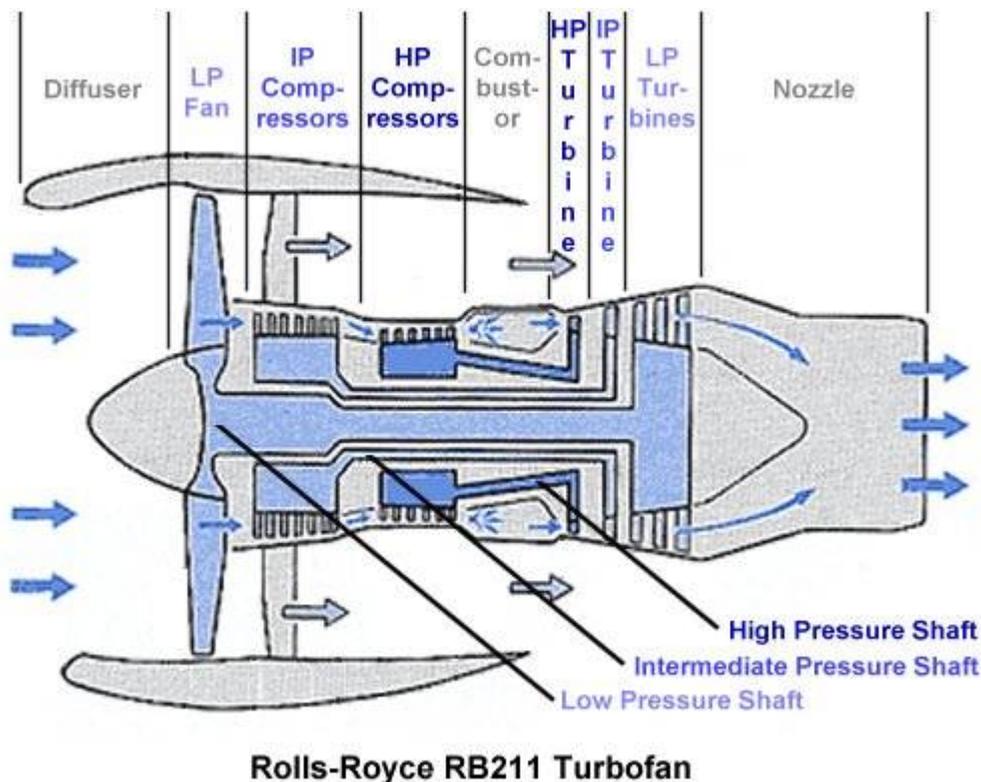
RB211 schematic illustrating the low, intermediate, and high pressure shafts

The LP shaft rotates within a shorter, larger diameter shaft that drives the intermediate pressure (IP) system. This shaft rotates at a higher rate and connects the IP turbine stage to the six IP compressor disks. The third concentric shaft is the shortest with the largest diameter and highest rate of rotation to drive the engine's high pressure (HP) system. This shaft connects the HP turbine to the six HP compressors. The debris photographed at the Pentagon appears to be connected to three concentric shafts of increasing diameter, suggesting that it most likely comes from the high pressure system of a triple-spool turbofan like the RB211-535.

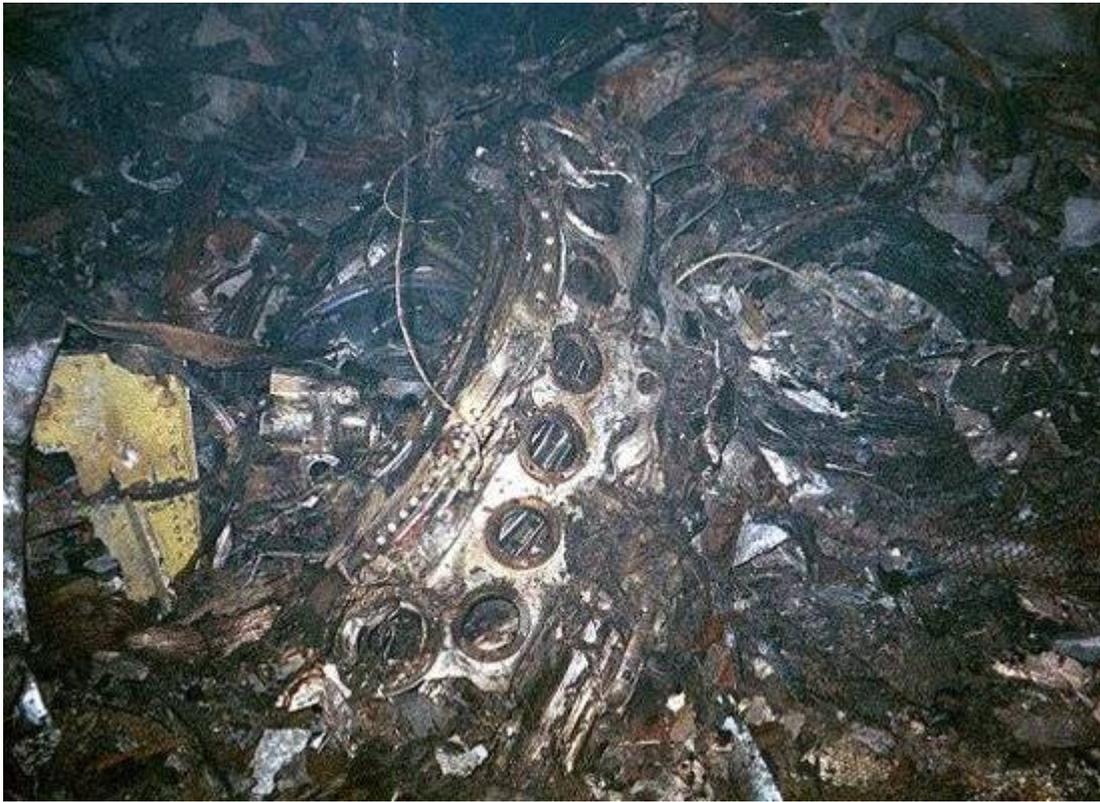
Another piece of engine debris found at the Pentagon

This item appears to be part of the casing of the combustion section. This portion of a jet engine is located aft of the compressors, and it is here that the high pressure air is mixed with fuel and ignited. The circumference of this circular casing contains several holes through which fuel injectors spray the jet fuel needed for combustion. The number, size, and shape of these nozzle holes is generally unique to a particular engine type and can be used to identify the engine model it comes from. Based on the curvature of the debris, the piece shown here appears to be about half of the total combustor case. We can count six nozzle ports along its circumference from the region nearest the floor around to the top, which represents about one-third of the total case. We can also see six screw holes along the circumference of each nozzle port that are used to attach the fuel injectors.

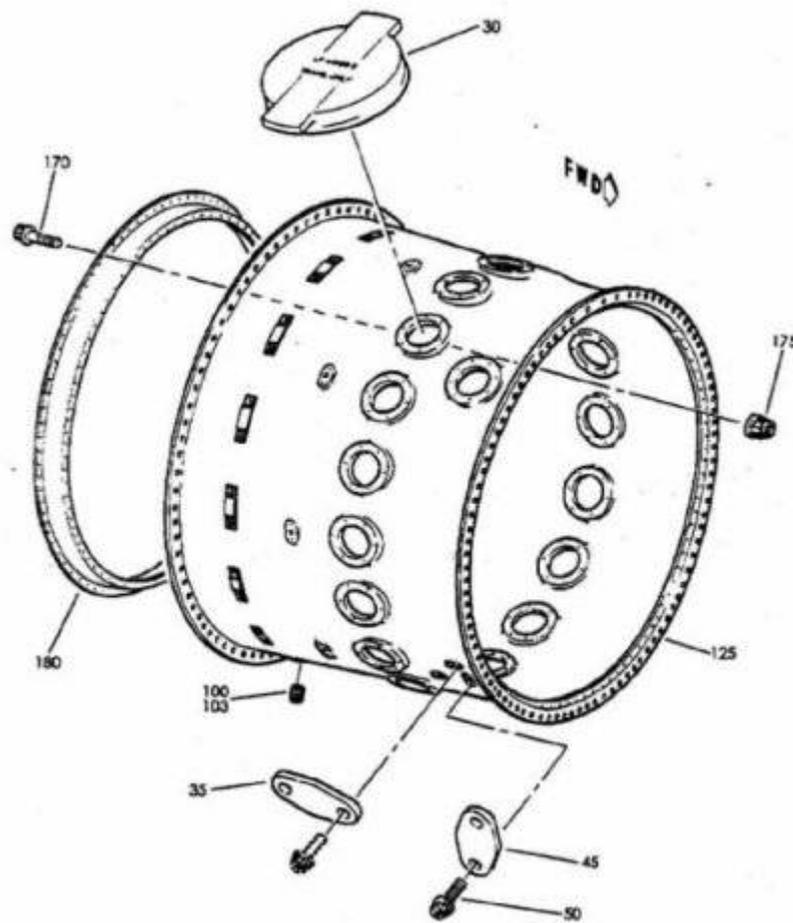
COMBUSTION OUTER CASE (RB211-535)
FIGURE 1 (SHEET 4)

The best photos we have found illustrating the design of this part on the RB211-535 series engine come from the Boeing 757 maintenance manual. A diagram from this manual shown below illustrates components of the RB211-535 high pressure system and its location relative to the rest of the engine.

RB211-535 combustion outer case

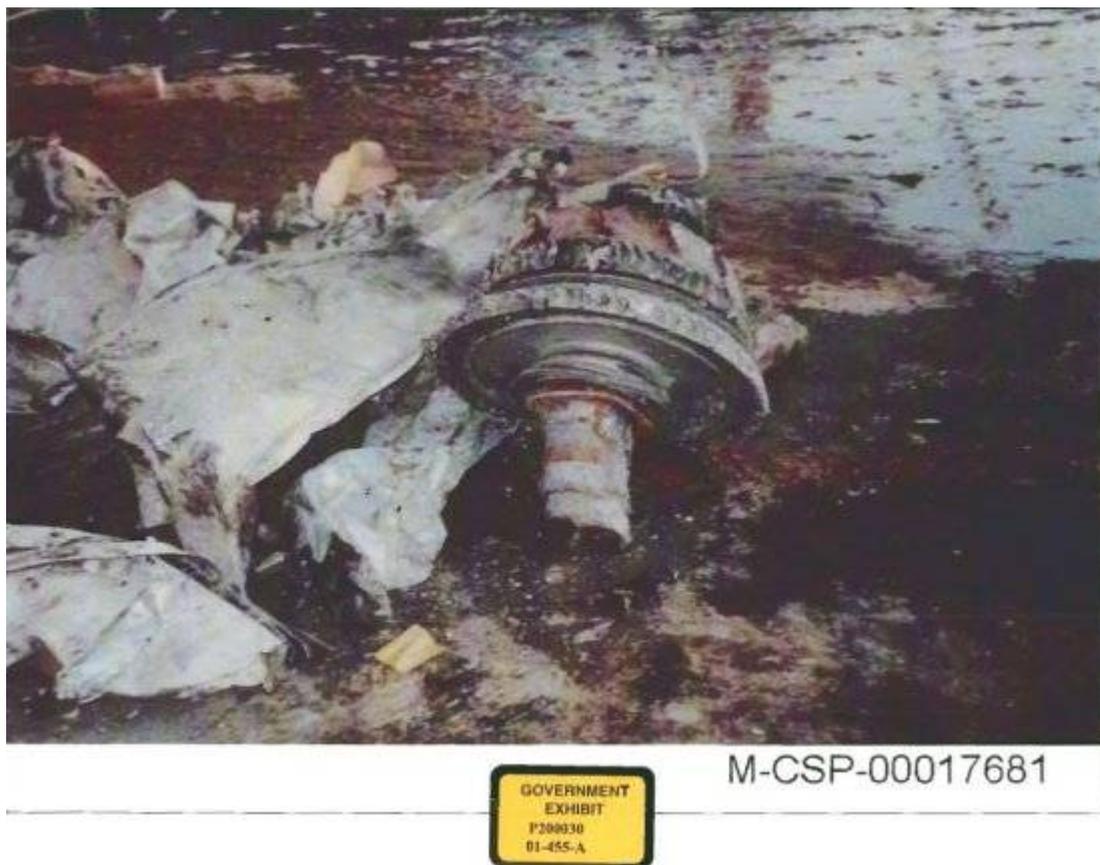
Piece of engine debris photographed at the Pentagon

This debris appears to contain two rotating engine disks with part of the engine's central shaft protruding forward. Behind the two disks is another component called a frame. Frames are fixed, non-rotating components that provide attachment points holding the engine together. This debris must come from the aft section of an engine given the shape of the blade attachment points visible along the circumference of the two rotating disks. These attachments have a highly cambered, or curved, banana-like shape indicative of the blades used in the turbine section of a jet engine. The blades used on fan and compressor stages, by comparison, have a much straighter and less curved shape.

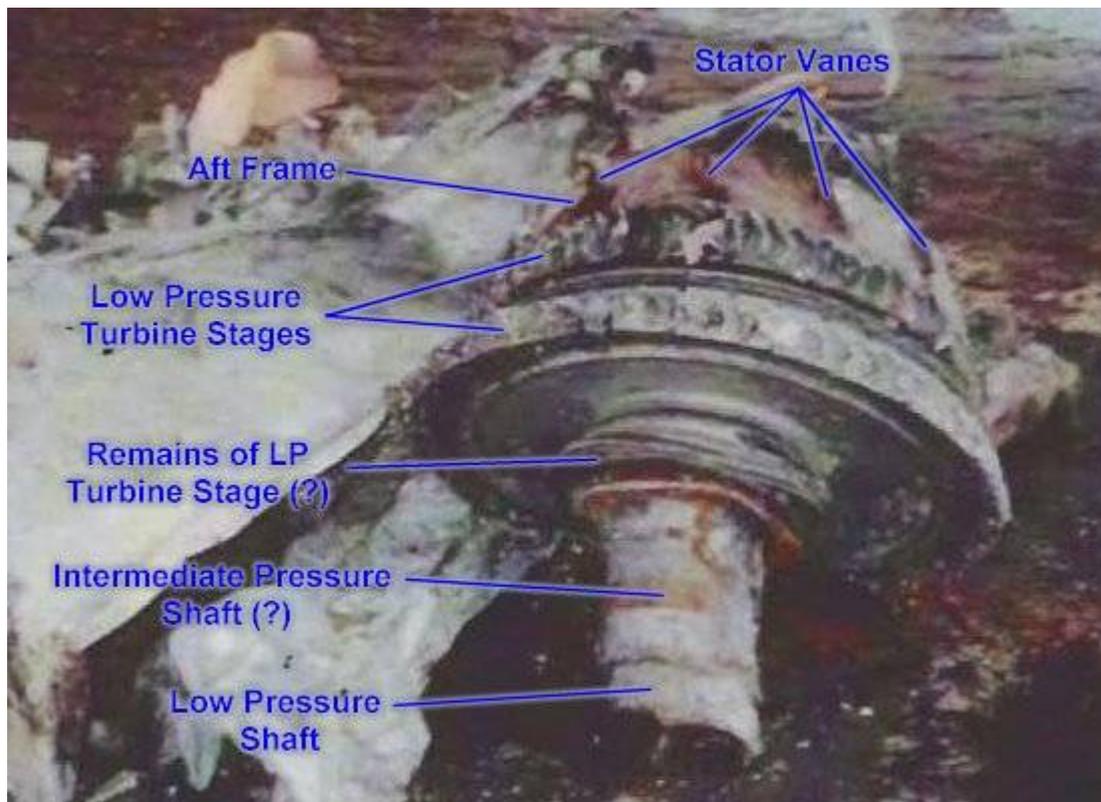
Closer view of the turbine section debris

The RB211-535 engine used on the 757 contains five turbine disks--three low pressure turbines that power the fan, one intermediate pressure turbine driving the intermediate pressure compressors, and one high pressure turbine that turns the high pressure compressors. The debris shown here contains two of the three low pressure turbines and possibly the remains of the third. The protruding shaft also appears to be composed of two separate shafts of differing diameter. A small portion of the inner shaft, from the engine's low pressure system, appears to protrude from inside a second larger diameter shaft surrounding it. This larger diameter shaft corresponds to the intermediate pressure system and would connect to an additional turbine disk that is no longer attached.

Though it is difficult to conclusively identify these components as part of an RB211-535 engine without better pictures of an intact engine for comparison, perhaps the most identifiable object shown in debris is the aft frame. Along the circumference of this frame are several fixed blades called stators that help guide the air as it flows through the engine. We can see the remains of four of these stators in the photo over about a third of its diameter.

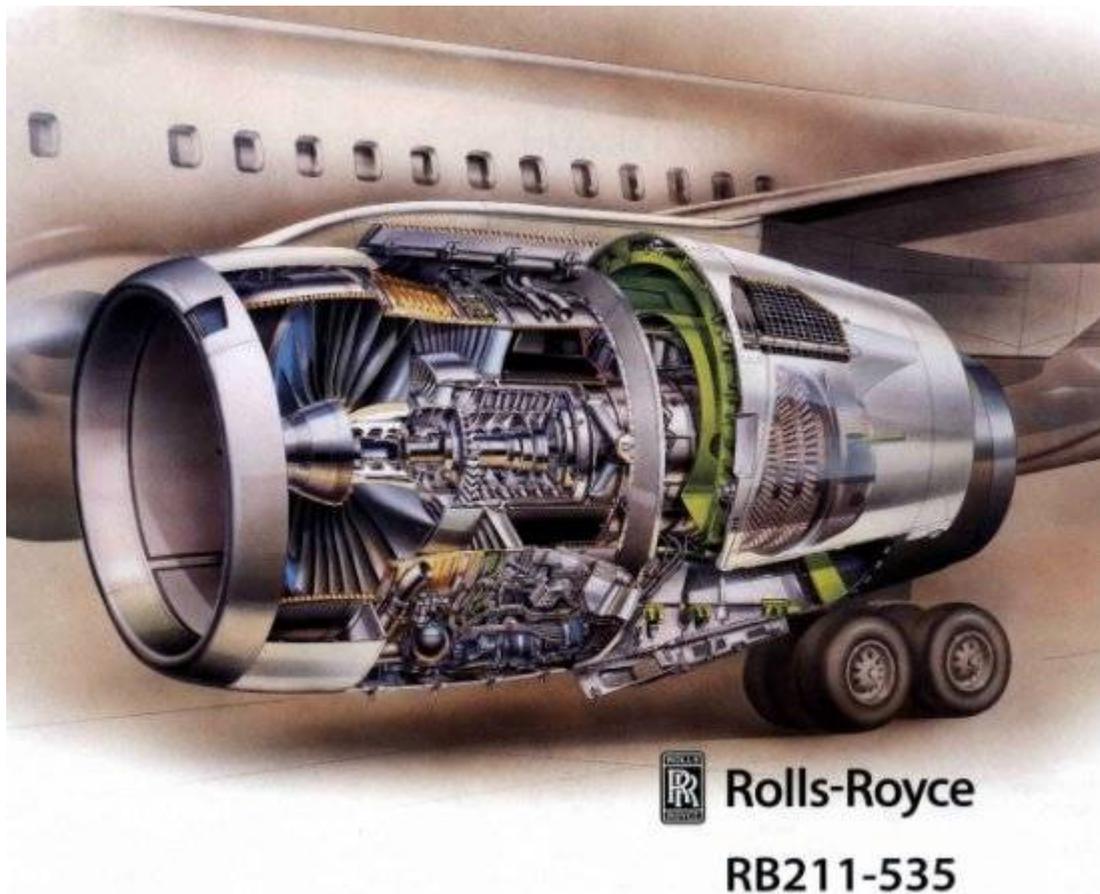
Cut-away diagram of the RB211-535 fitted to a Boeing 757

The above illustration from Rolls-Royce shows another cut-away of the RB211-535 that provides a good view of the internal components of the engine. In particular, note the frame just aft of the turbine stages. The spacing of the stator vanes shown here matches those seen in the Pentagon photo well and provides additional evidence that the debris is in fact from an RB211 engine.

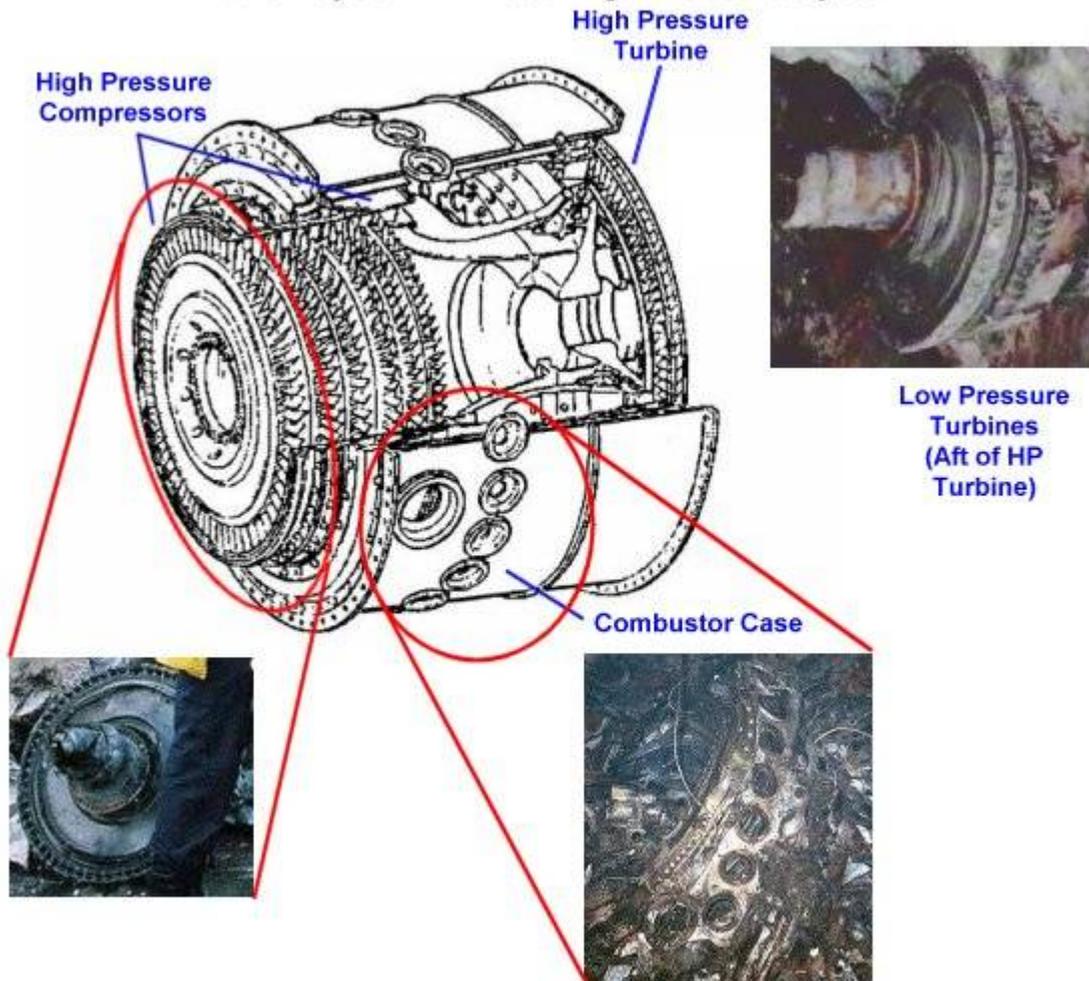
Rolls-Royce RB211-535 High Pressure System

RB211 high pressure system containing six compressor disks, combustors, and a turbine disk

To give a better idea of how the three engine components we have discussed relate to one another, the above image shows a diagram of the high pressure system within the RB211-535 engine. Also included are the objects identified in the Pentagon wreckage and their relative locations within the engine. As discussed in the main article, all three of these pieces of debris are identical matches to or at least consistent with the components found in the Rolls-Royce RB211-535 turbofan aboard a Boeing 757.
