Hardfire: Critical Response to Tony Szamboti

Ryan Mackey September 2009

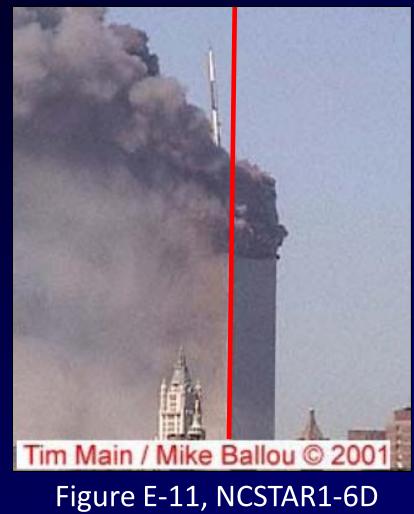
Figure 2-17, NCSTAR1-1

WTC 1: Tilt onto Floors Below

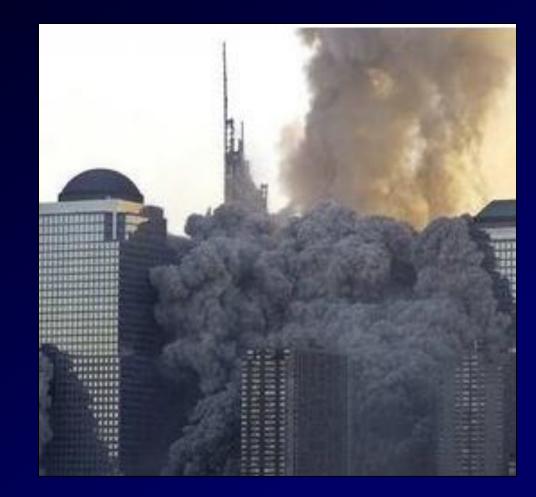
WTC 1 and 2: Surviving Core Structures

- In both collapses, building cores were the last pieces left standing
- Shown: WTC 1 collapse
- Core remnant is approximately 70 stories in height
- Clearly, the cores were not destroyed by explosives

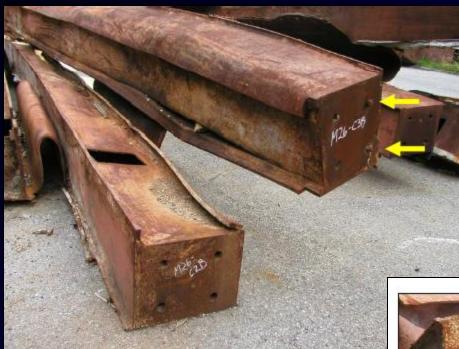
Recovered Perimeter Columns

Figure 3-47, NCSTAR1-3C Perimeter column from WTC 1 Floor 92

Figure 3-42, NCSTAR1-3C Perimeter columns from WTC 1 Floors 90-93

- Mr. Szamboti's hypothesis requires nearly every column connection to be deliberately destroyed (explosives?)
- NIST recovered many columns, with intact ends, from the debris
- None of them were destroyed by explosives
- True for both perimeter and core columns
- In fact, absolutely no recovered steel of any type shows signature marks of explosives

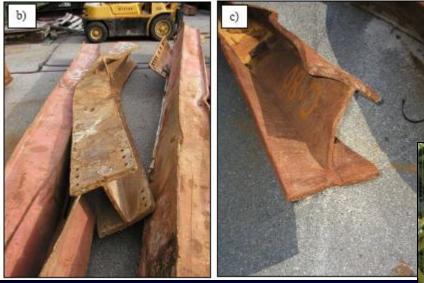
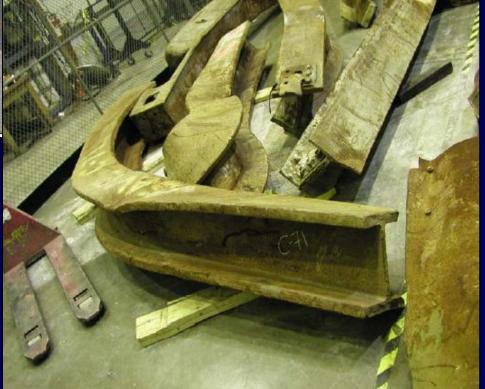
Recovered Core Columns

Figure 3-12e, NCSTAR1-3B Recovered core columns from WTC 1

Figure 4-1, NCSTAR1-3C Core column from WTC 1 Floors 92-94

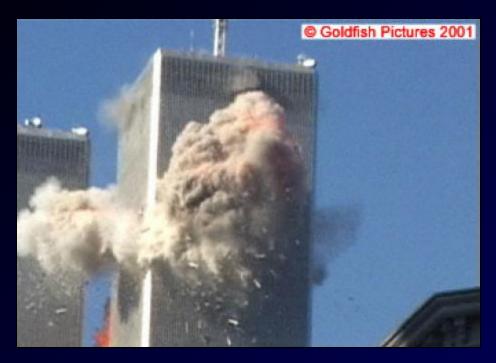
WTC 1: Fireproofing Damage

Figure 6-1, NCSTAR1-5A WTC 1 Impact + 3.5 seconds, North Face

- NIST does not predict *all* fireproofing on far side from impact removed
- Only where fuselage went through, and some went through at very high speed
- Evidence, the opposite section punched out at impact
- Also, many researchers have calculated that even with intact fireproofing, collapse was inevitable
- Collapse started on that side due to prevailing winds, pileup of combustibles, and longer floor trusses. This was the weakest point. (verify side)
